## S.C. MOTORSTAR S.R.L.

As regards the issue of inspection of the engine after a propeller strike, we usually find that when propeller strike happens, the main engine part that it is affected is the shaft that connects the crankshaft with the accessories case across the supercharger (the part from the next picture).

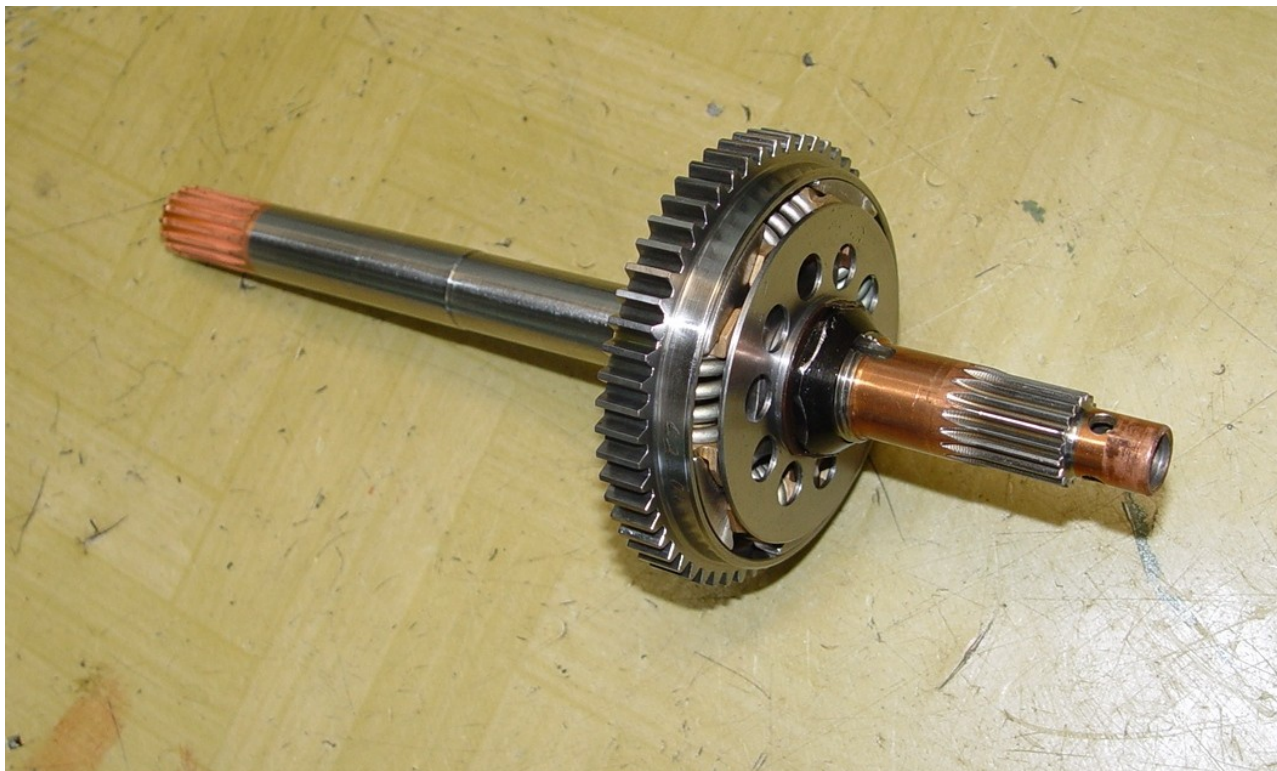
About our experience on three cases from four propeller strikes, this shaft was broken or twisted on the spline zones. We strongly recommend that this item to be inspected at least, because this shaft drives all the engine accessories (magnetos, fuel pump, oil pump, etc.). If this shaft fails then the engine quits immediately.

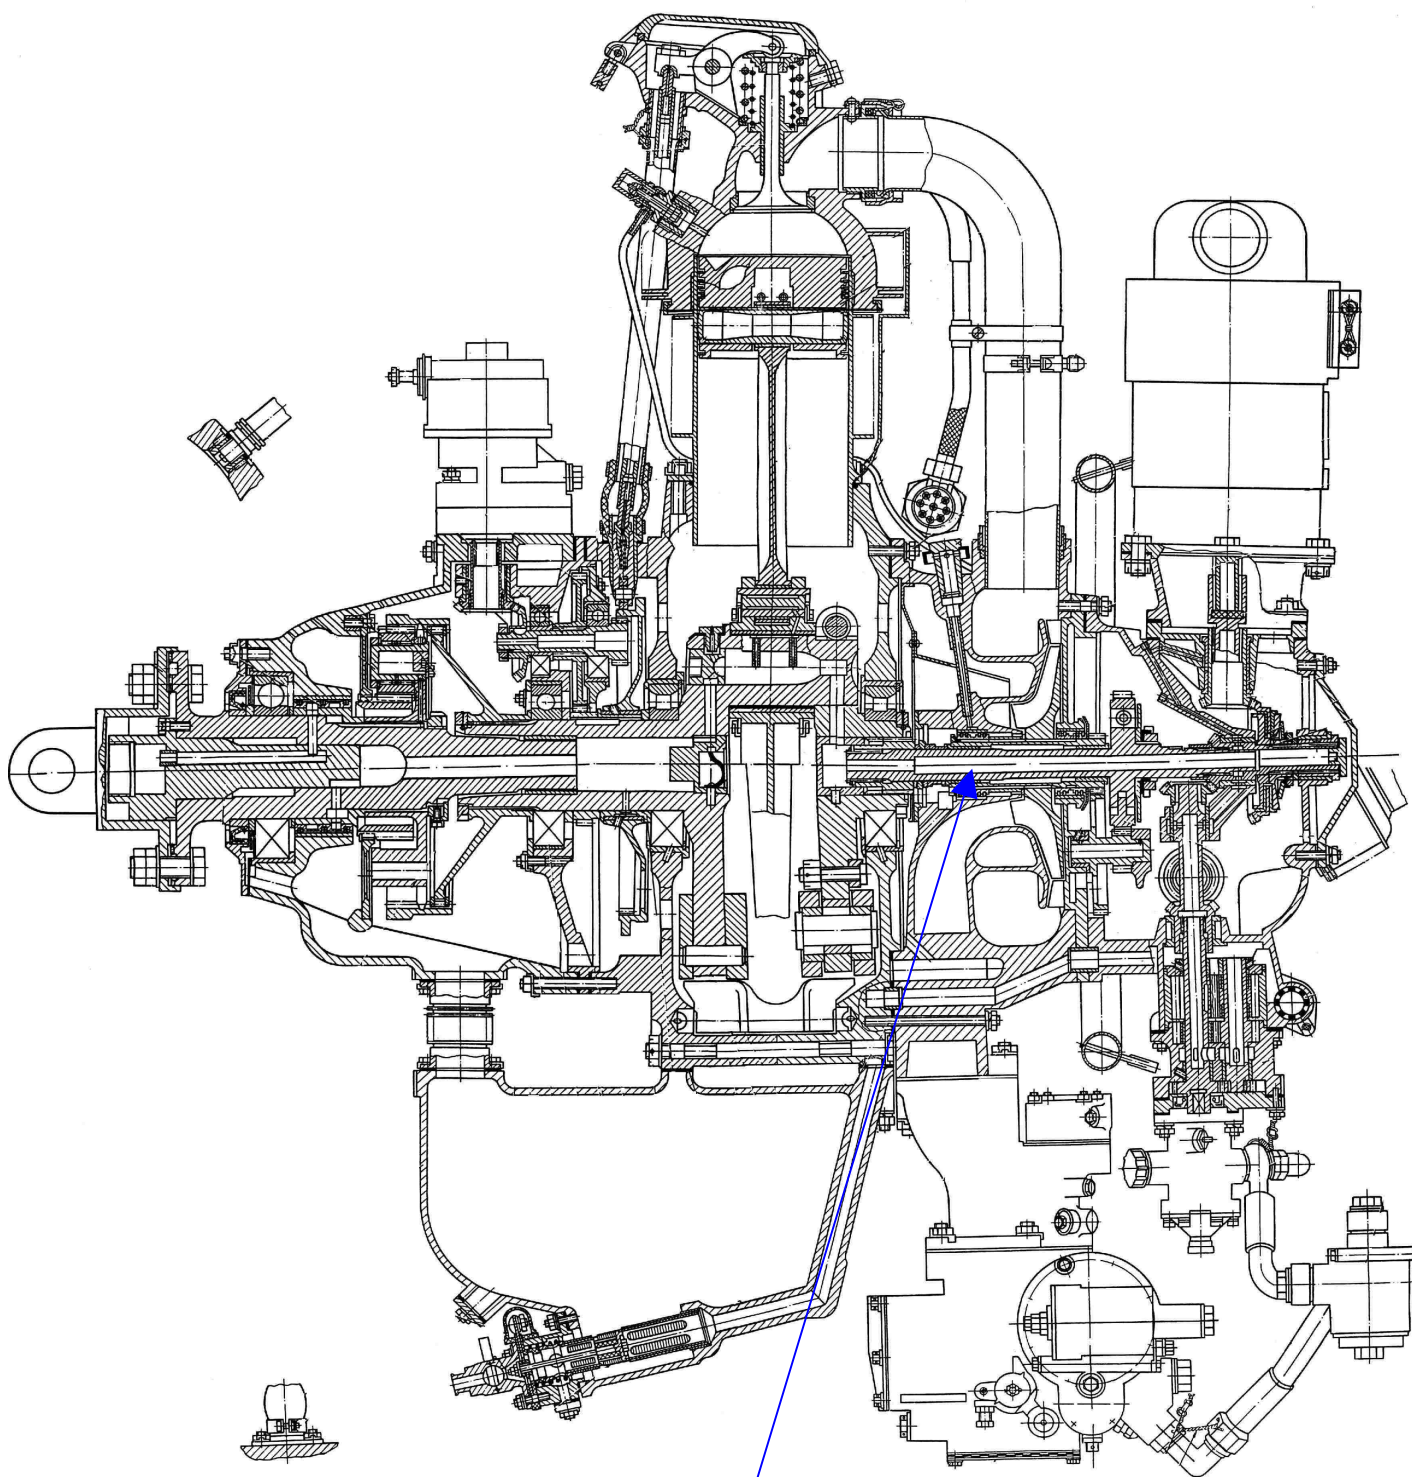
Accessories drive shaft

On the next drawing it is shown the position of this shaft on the M-14P engine.
